NASA Contractor Report 189628

**ANALYSIS OF SYSTEMS HARDWARE FLOWN ON LDEF -
RESULTS OF THE SYSTEMS SPECIAL INVESTIGATION
GROUP**

**BOEING DEFENSE & SPACE GROUP
Seattle, Washington**

**Contract NAS1-19247
April 1992**

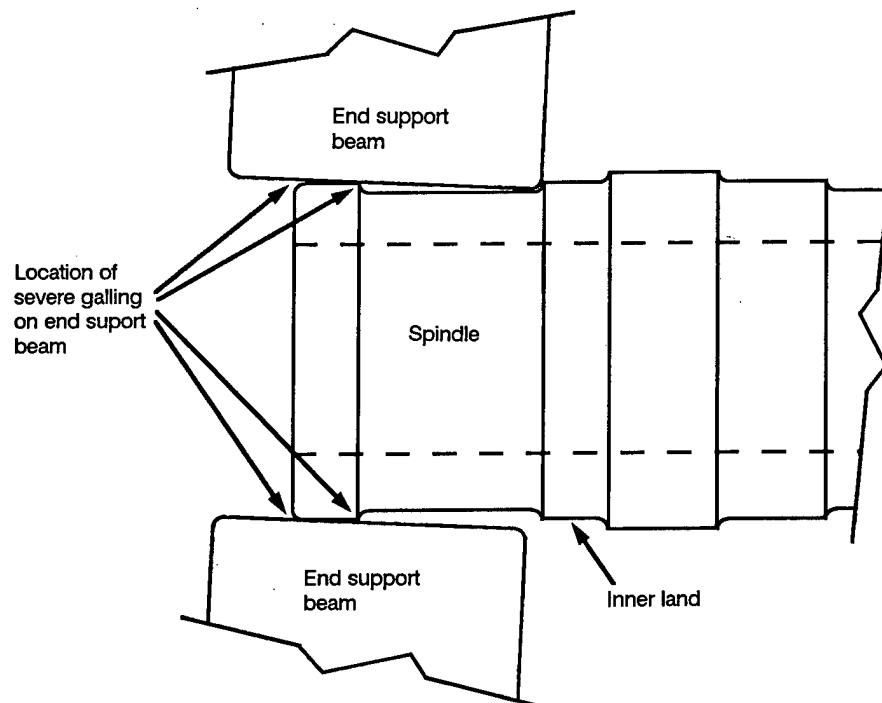
Flight Position of End Support Beam

Position of End Support Beam When It Became Stuck on Spindle During Removal Attempt

Figure 4.1.2-3. Schematic Illustration of Cause of ESB Seizure During Removal

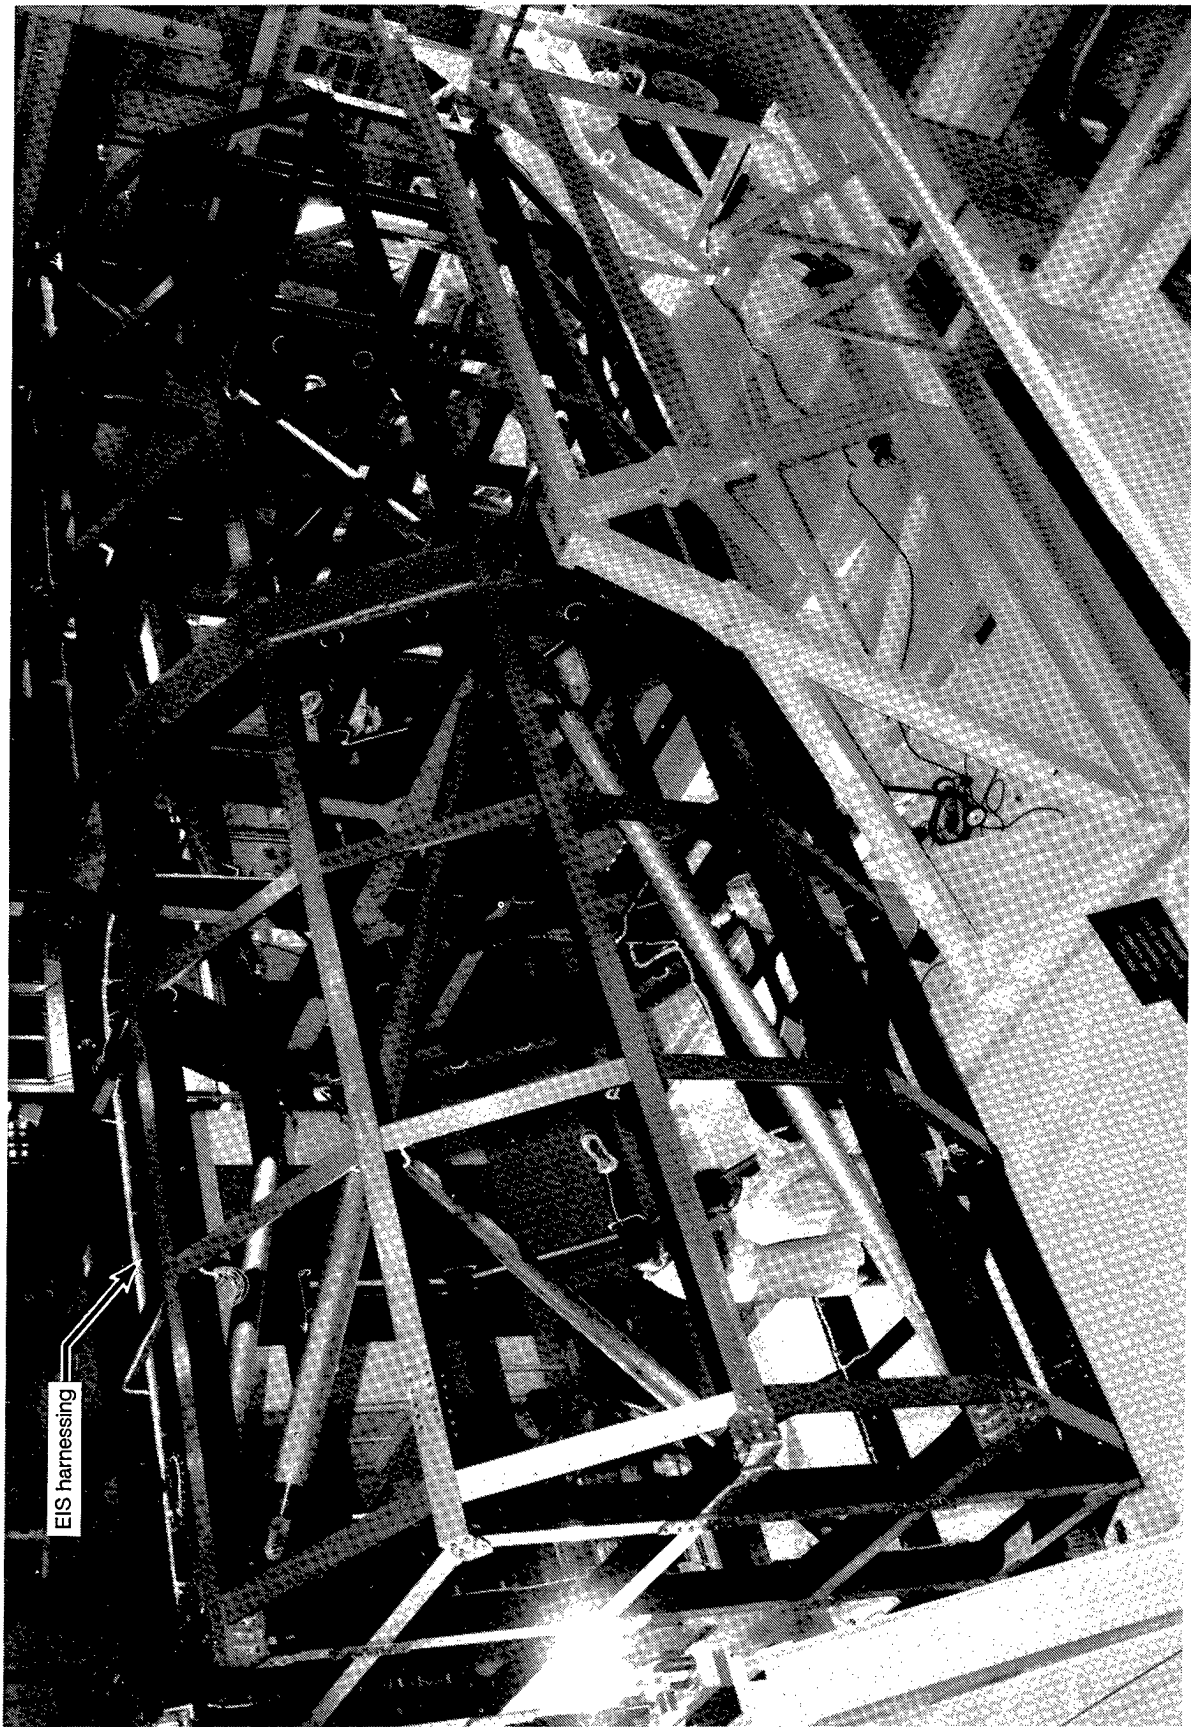
Figure 4.2.4-1. EIS Harnessing on LDEF Structure

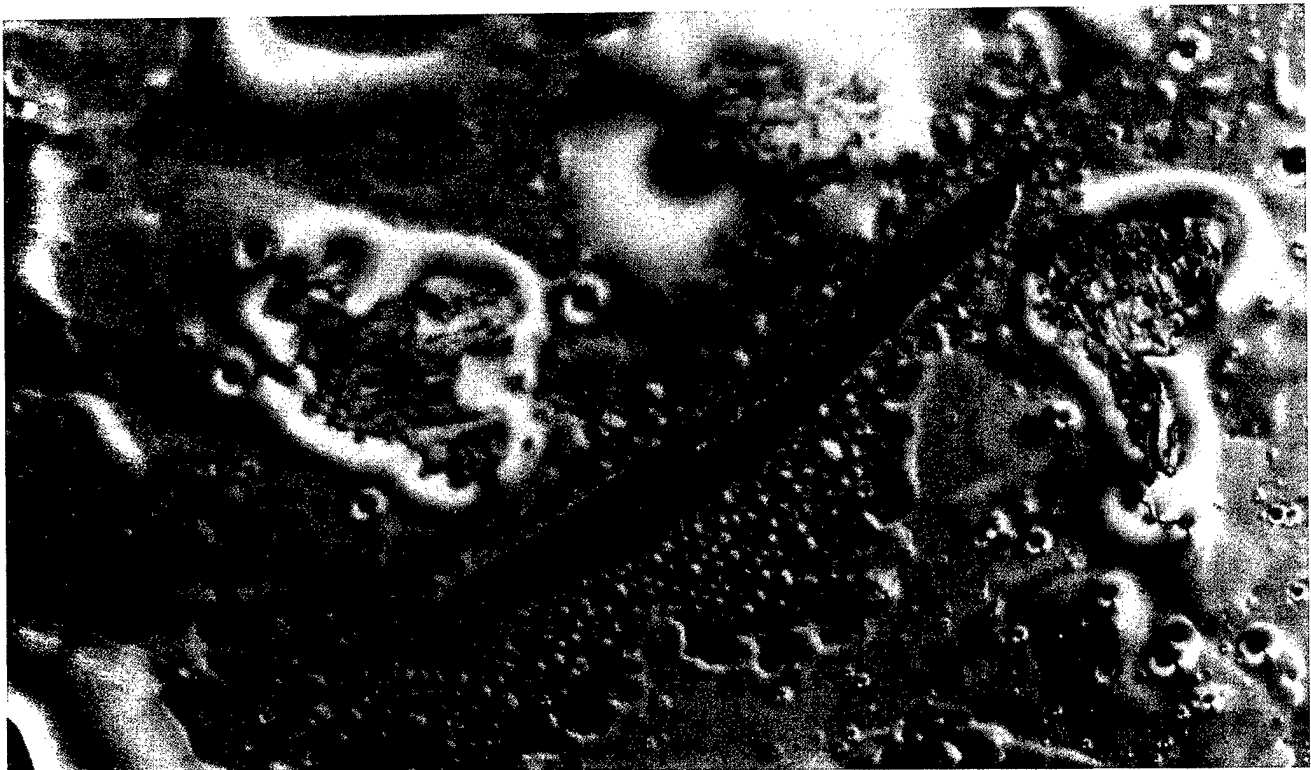
*Figure 4.4.2.2-2. Contamination on Laser Mirror Photographed at SAEF-2 at the Nomarski
Microscope Workstation. (Courtesy of E. R. Crutcher)*
